CULTURAL RESOURCES SURVEY

LONG BRANCH LAKE

Macon County, Missouri

HISTORIC ARCHITECTURAL RESOURCES

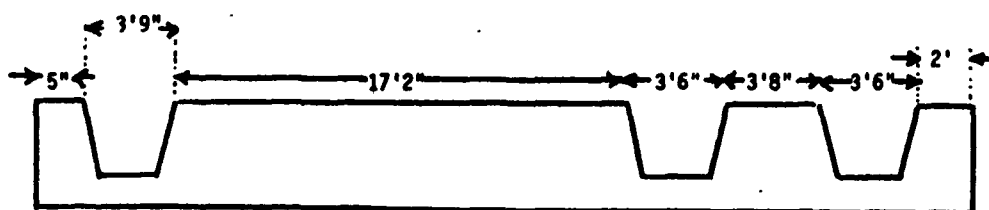
Detail of Barn Foundation (south wall)

The openings set into the barn foundation (see drawing below) may have served as access to crawl space below the floor, or to assist in removal of waste.

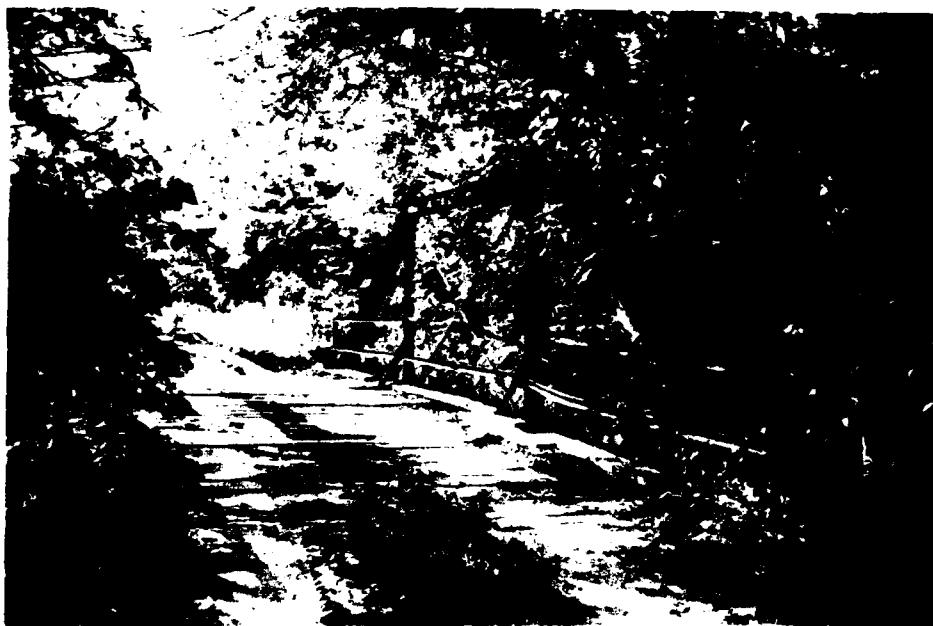
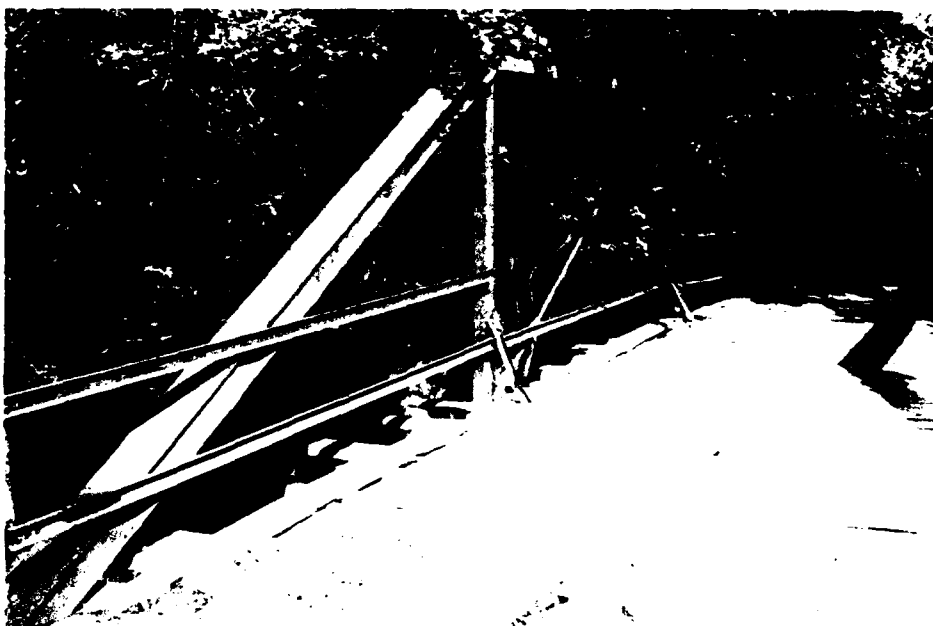
At time of inspection, bridge was in fair condition, loose planking, rusty.

The planking was of native lumber, machine sawed, in irregular lengths.

The bridge was in a good state of preservation.

Secondary road bridge, iron frame construction

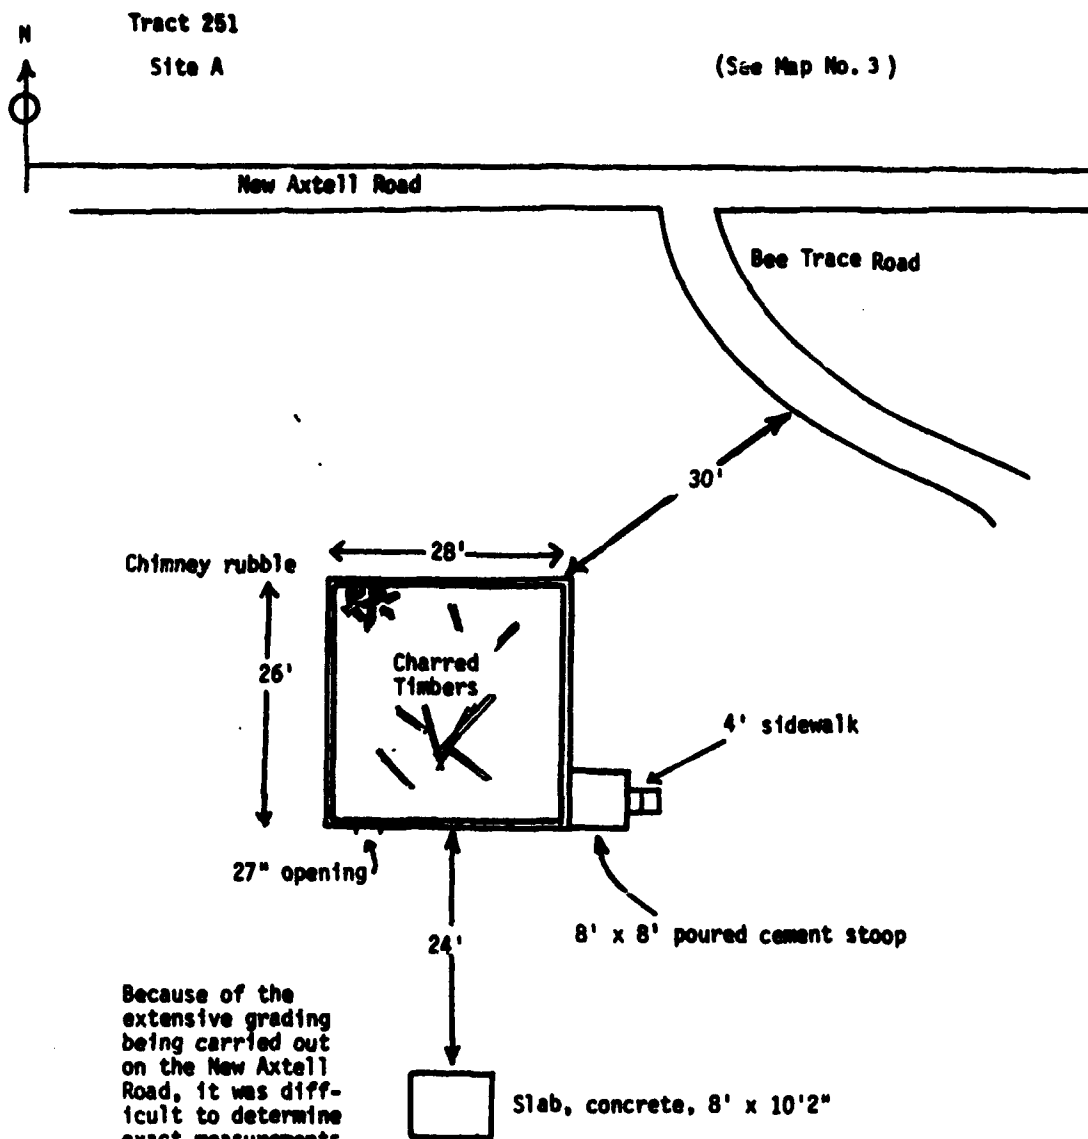
Inspected by Mary Jo Polak and Leon Karel, May, 1976
At time of inspection, Axtell Road was being regraded and widened,
and the original boundary lines were obliterated on two sides (N, E).
Only a few charred timbers and the original cement foundation
remained.

Because of the extensive grading being carried out on the New Axtell Road, it was difficult to determine exact measurements at this site. However, it is likely that this was the site of the New Fairview School.

From the evidence remaining at the time of the inspection, there was no way of determining the construction of the building, other than that it made use of wood timbers and rested on a cement foundation. Bee Trace Road was subsequently widened, and two months after the site was inspected not a trace of the building remained.

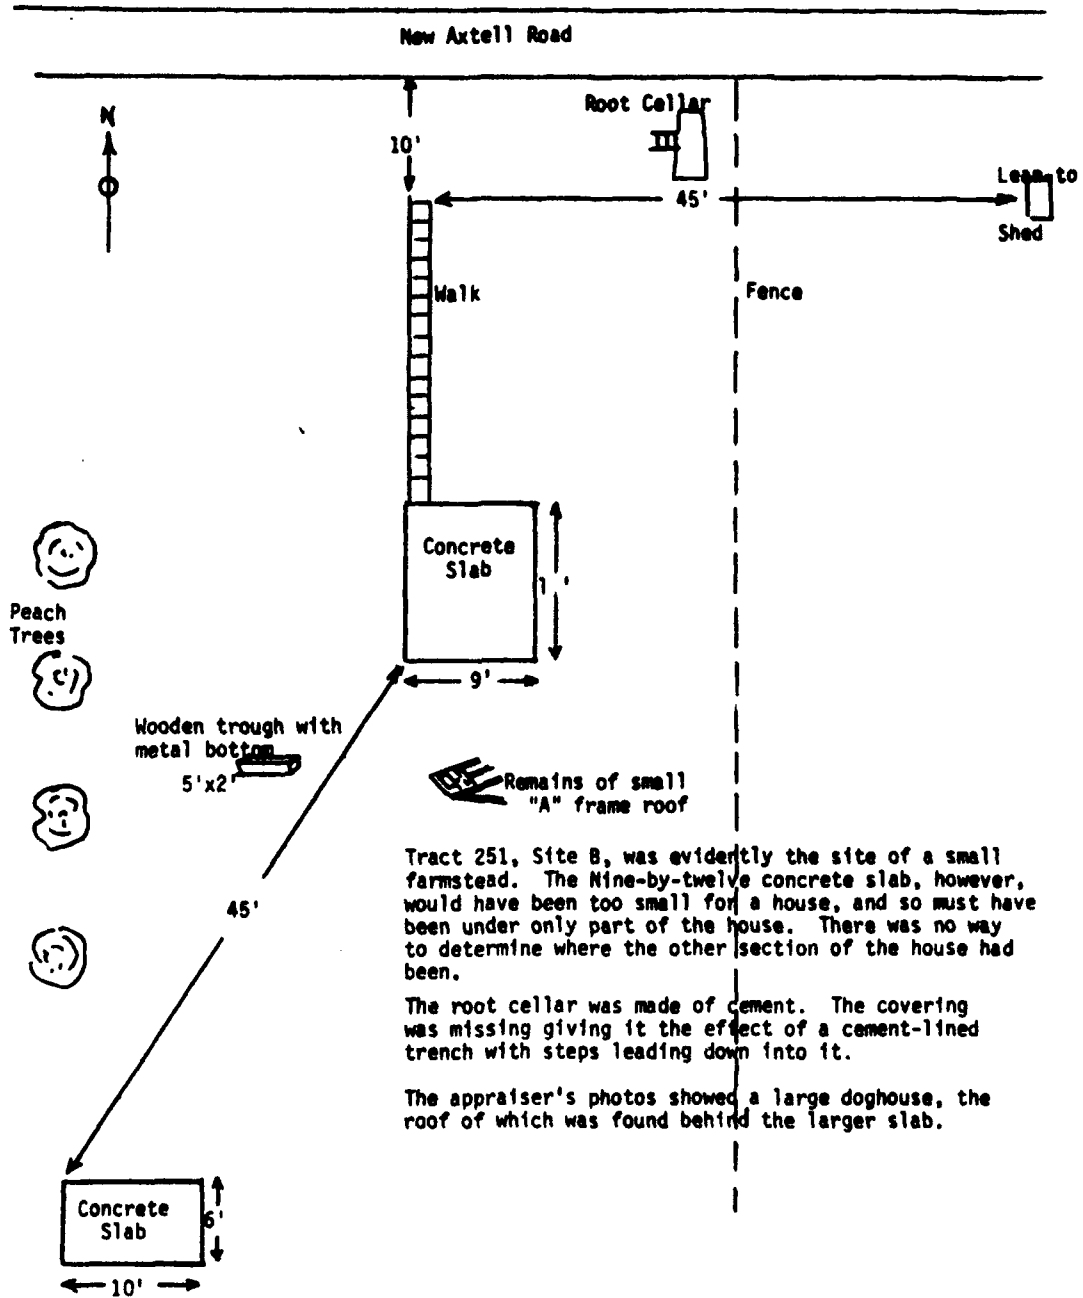
Tract 251, Site B, was evidently the site of a small farmstead. The Nine-by-twelve concrete slab, however, would have been too small for a house, and so must have been under only part of the house. There was no way to determine where the other section of the house had been.

The root cellar was made of cement. The covering was missing giving it the effect of a cement-lined trench with steps leading down into it.

The appraiser's photos showed a large doghouse, the roof of which was found behind the larger slab.

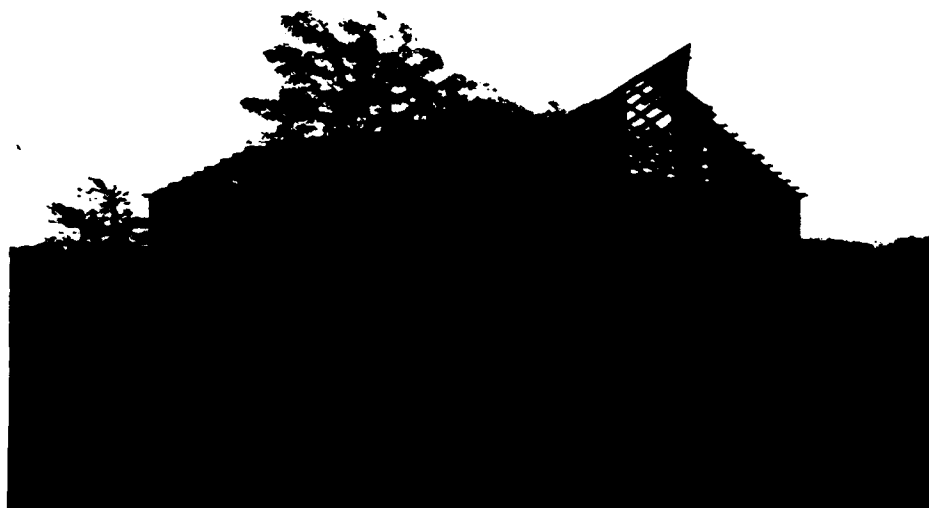
The barn on Tract 253 was of modern construction, using all native lumber. A poured cement foundation supported the structure, which was held together by bolts and nails.

Large barn, viewer facing Northeast

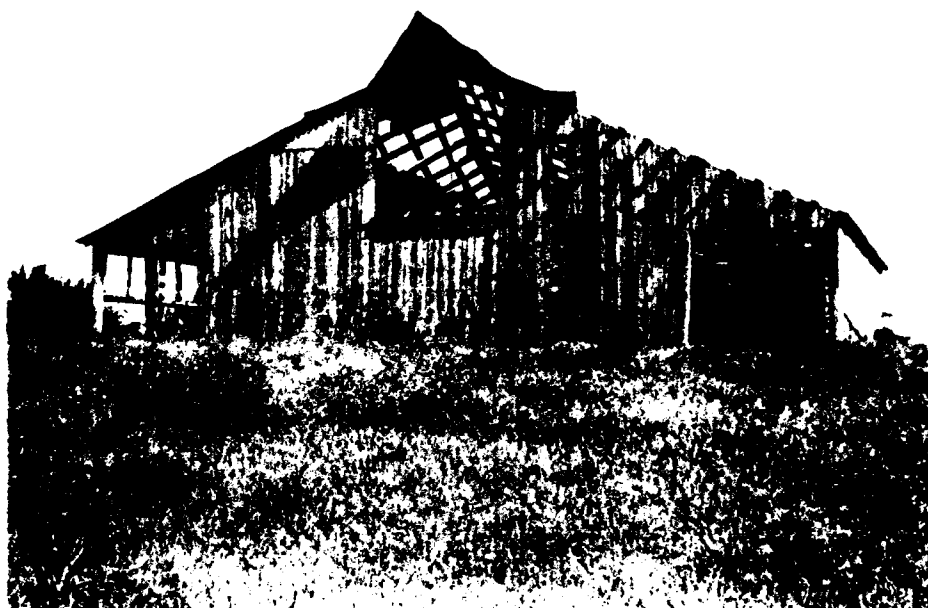
On both sides of the barn, there were numerous large stones piled against the foundation, probably to keep hogs from rooting and wallowing there, and thus damaging the foundation boards.

Barn front, viewer facing North

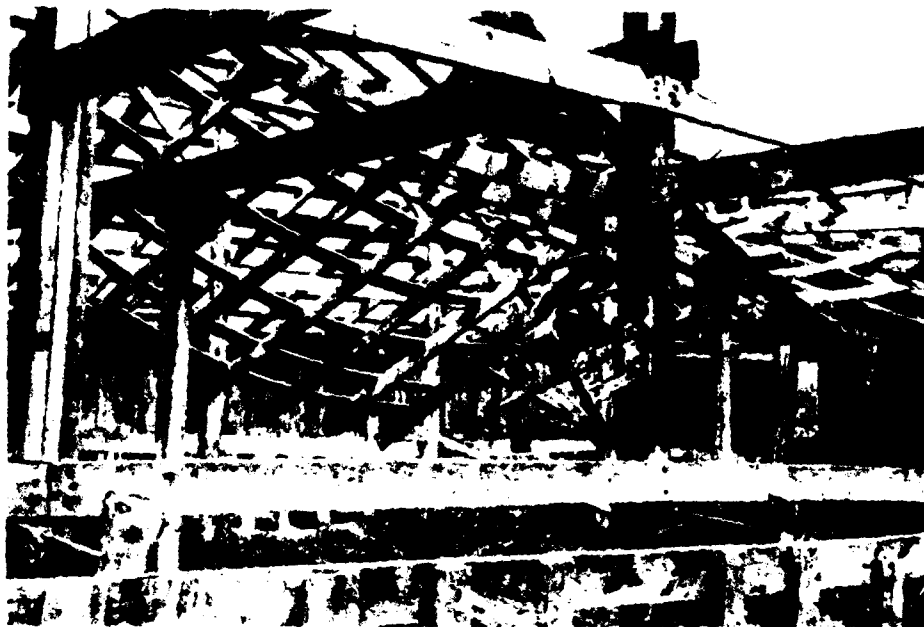
Detail of rafters.

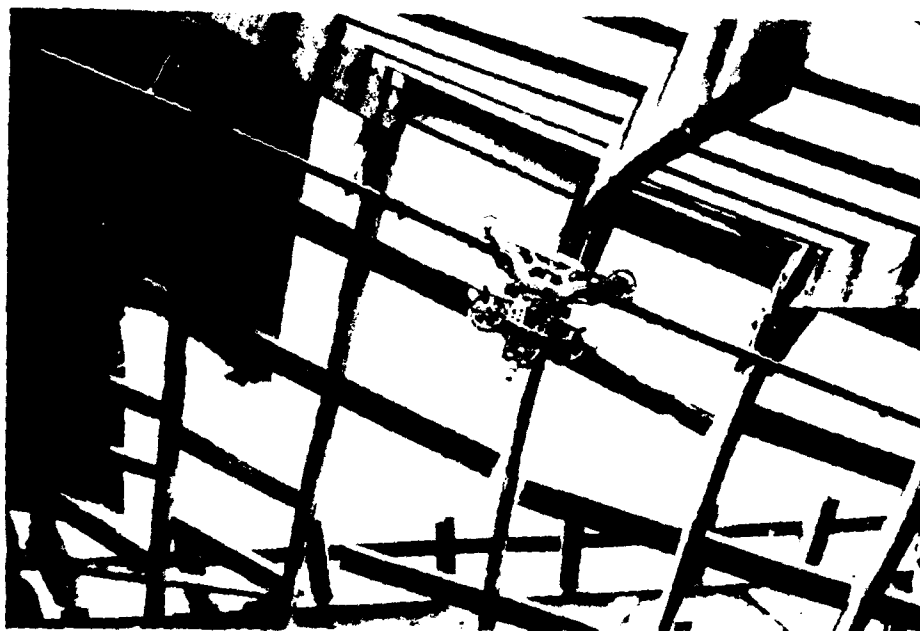
View of pulley device in hay mow

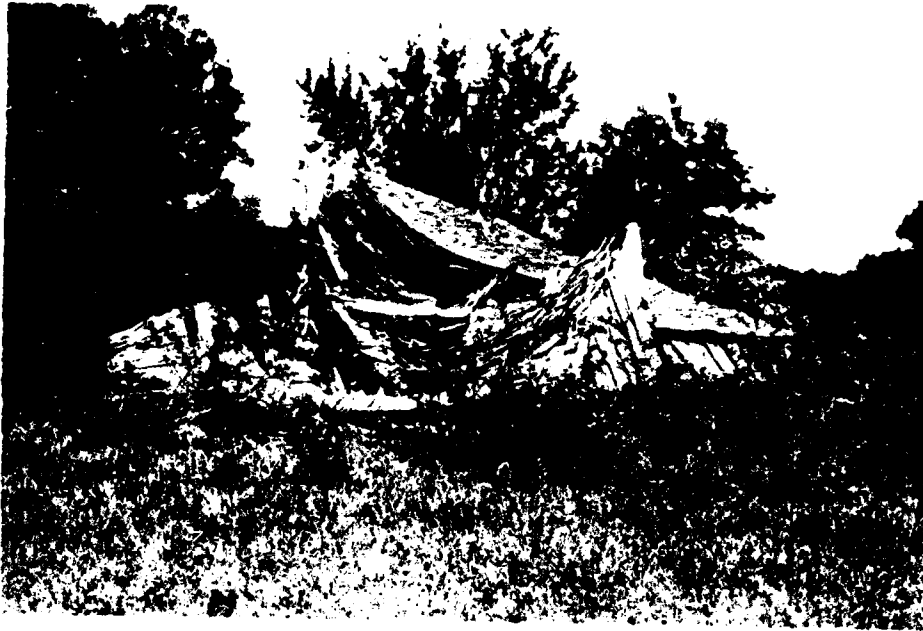
The whole structure was in a state of collapse but details of the log framing were visible (see photographs). The log ends were notched in the simple fashion of crude, temporary shelters, and siding of native sawn lumber was applied vertically over the logs for additional stability and weather protection. There was no evidence of chinking in the logs.

Collapsed barn
